Figure 1: Folsom Dam, showing the 4 sluice gates (4 upper and 4 lower tier) that will be replaced. Also see the radial gates near the top of the dam, and a portion of the stilling pond at the bottom of the dam.

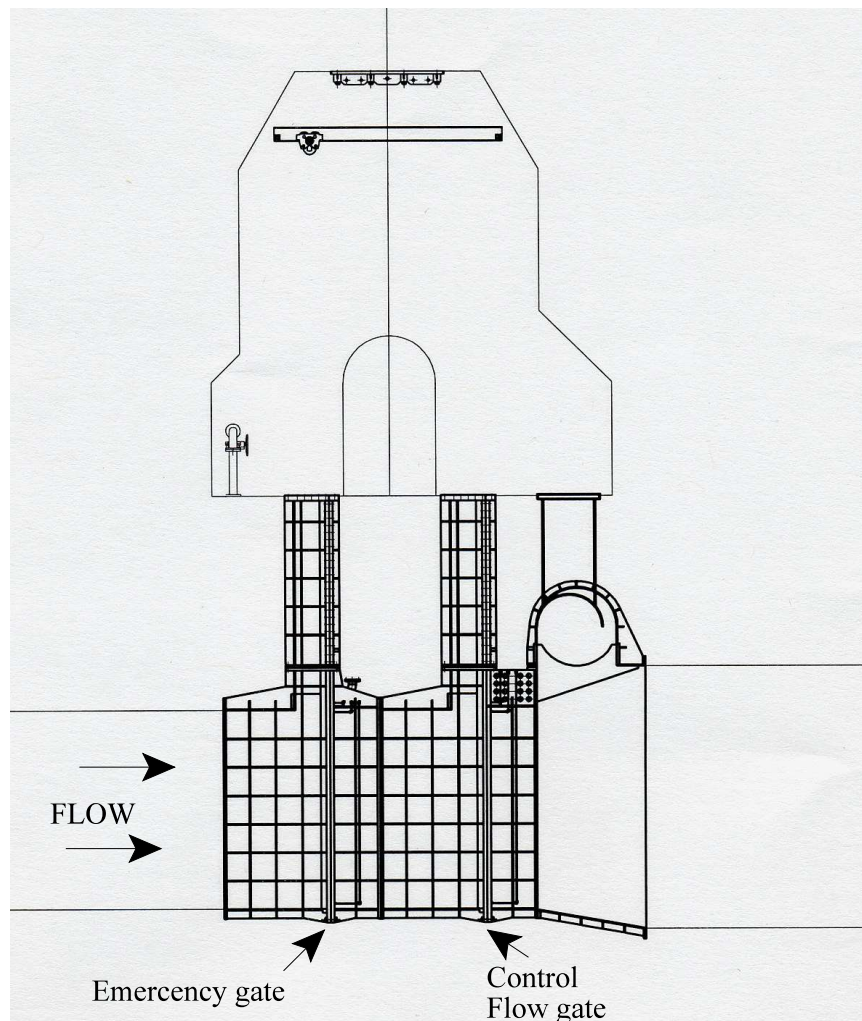
Figure 2: Diagram showing the configuration of the sluice gates, with an emergency gate that is typically left open and the control gate. The gates are housed in a steel body, with a bonnet above it into which the gates are raised. The bonnet cover is just above the floor level in the galley (not shown). The sloped section, just down stream of the gate body, is designed to reduce cavitation. Air is introduced around the water stream here to provide a "cushion" to help dissipate the energy from exploding bubbles.

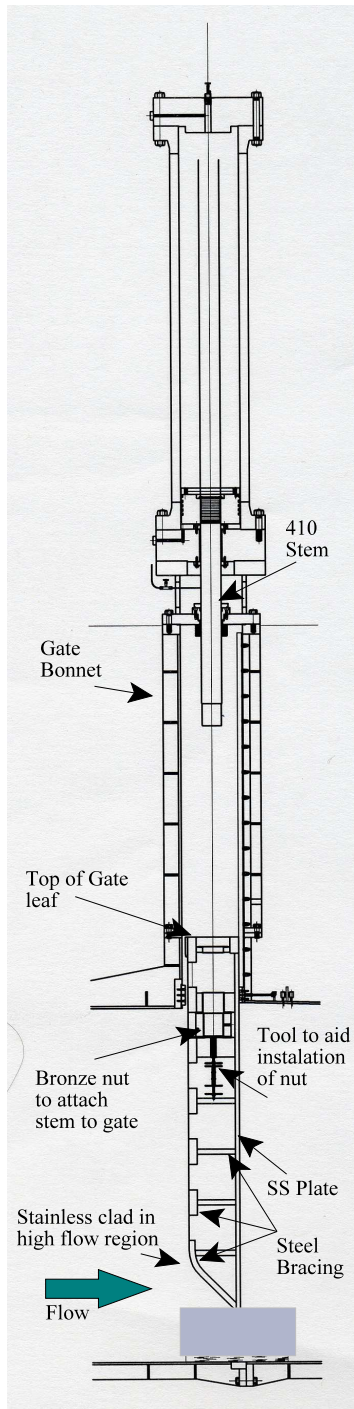
Figure 3: Diagram showing the leaf, bonnet, and piston.

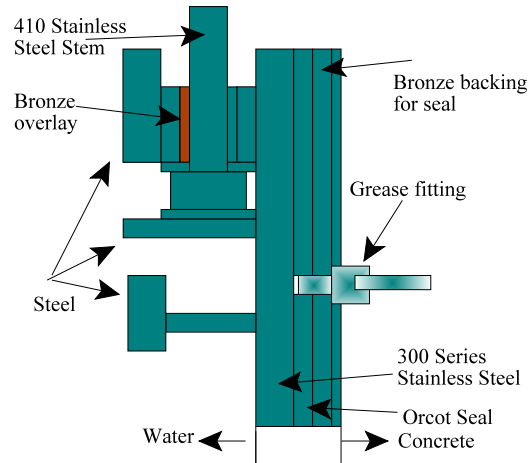
Figure 4: Detail, not to scale, showing materials in leaf and seal. A BOR detail of this region is shown in figure 16.

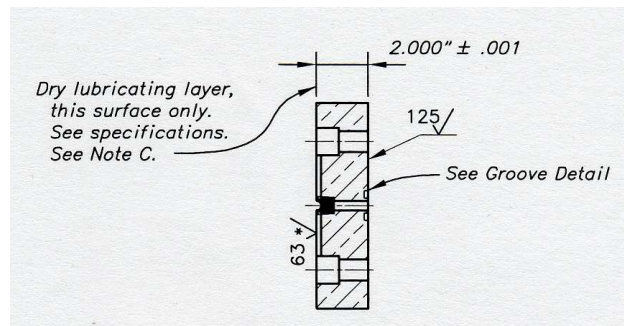
Figure 5: Diagram showing the grease fitting detail, with o-ring, and fasteners holding the seal backing.

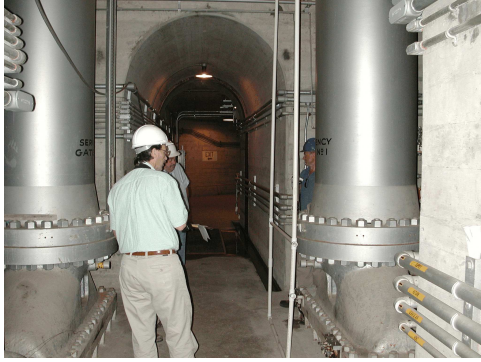
Figure 6: Inside gallery showing the tops of the emergency and control bonnets and the hoists.

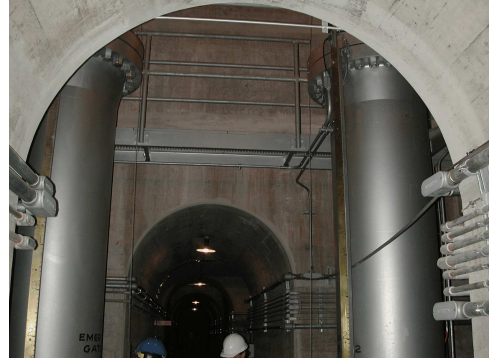
Figure 7: Inside gallery showing the tops of the hoists.

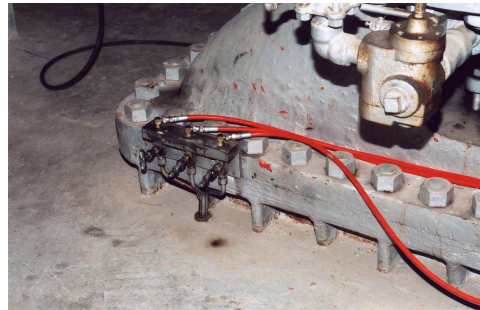
Figure 8: Connections for bonnet cover and grease fittings for the seals.

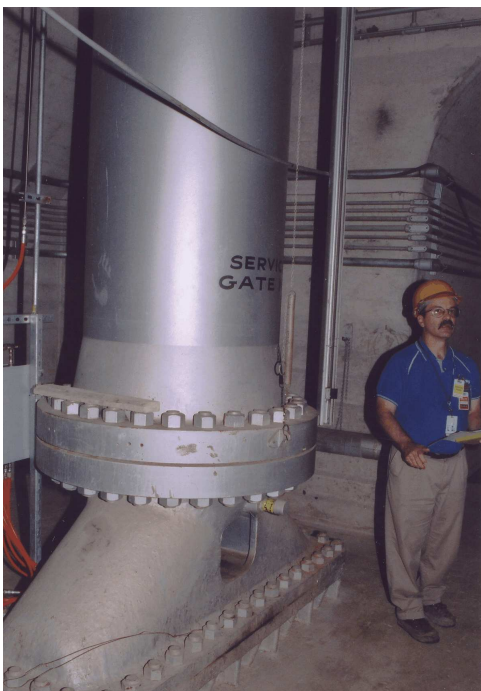
Figure 9: Bonnet cover.

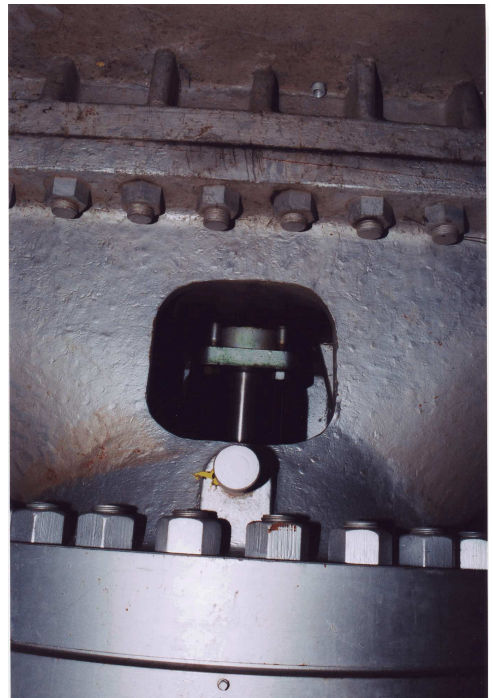
Figure 10: Access hole for the stem glands.

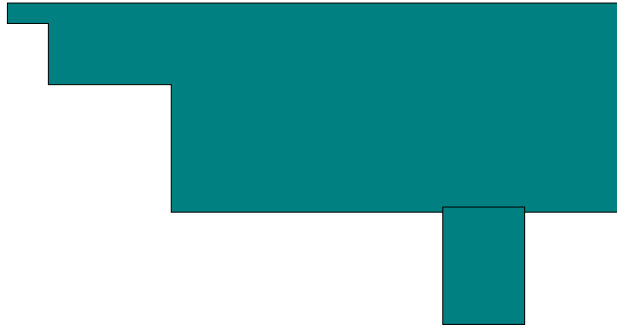
FIGURE 11: Diagram showing the materials and configuration of the leaf seal at the sides of the gates. A BOR detail of this region is shown in figure 15.

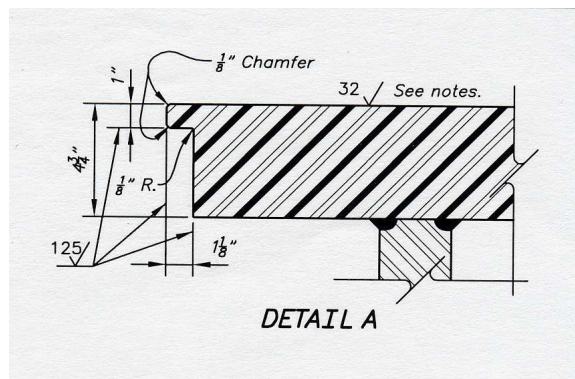
Figure 12: Scale drawing of the sealing edge of the leaf.

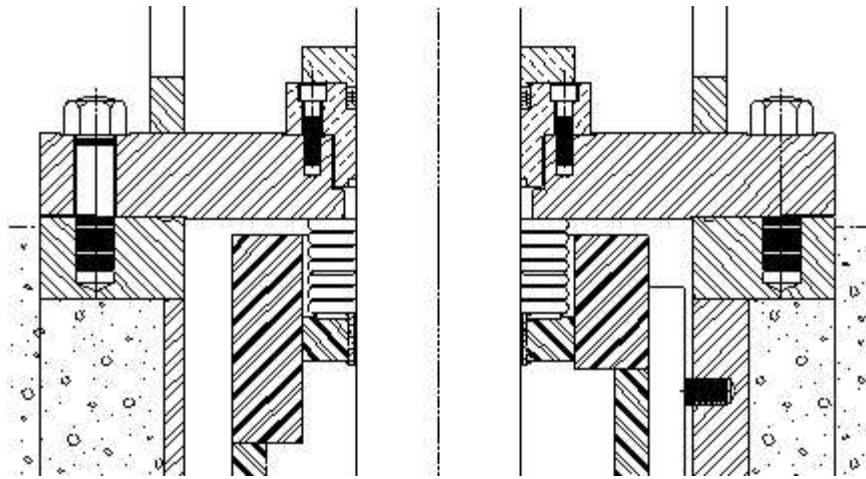
Figure 13: Elevation section through the centerline of the hoist stem as it passes through the bonnet cover and gland assembly. The leaf in all of the figures is shown all stainless as we discussed was a possibility. The multiple ring around the stem shown in section squeezed between bonnet cover and leaf is a neoprene gasket with brass plates included to seal the gland should it have to be removed with water head on the gate. You can see that it is bulged in the view.

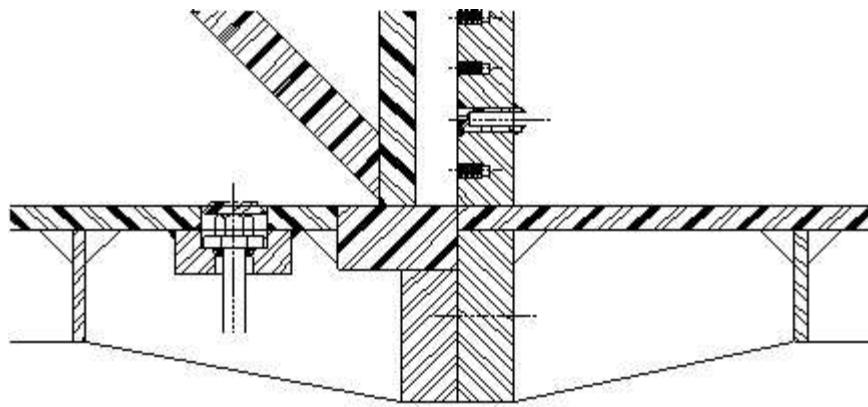
Figure 14: A vertical section through the bottom sealing edge of the leaf. The flow is left to right and the bottom seal or seal clamp is not shown.

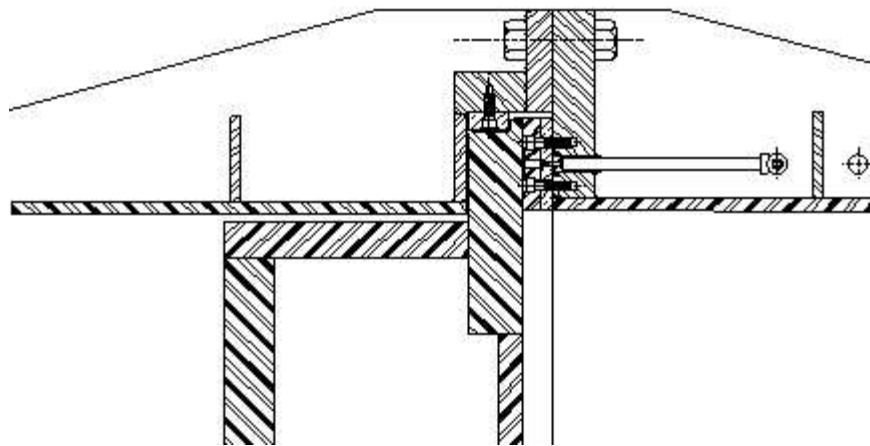
Figure 15: SECT3 is a horizontal section through a gate slot with leaf, seat, and guide all shown and, of course, the upstream and downstream bodies.

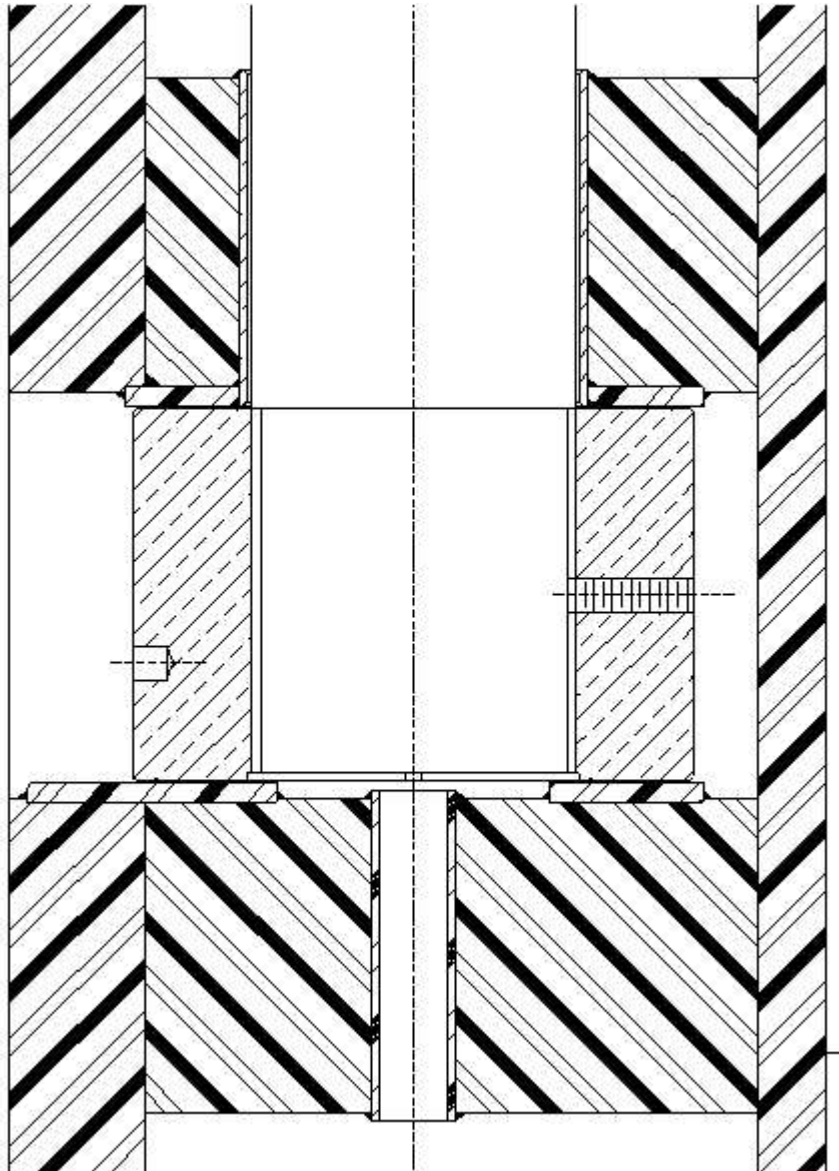
Figure 16: A vertical section through the stem nut in the leaf. The stem is not shown in section so there is no crosshatching on it.
